Investigations of Cost-Effective ESP-Upgrade Measures for a Life-Time-Extension in a Grid-Stability Operating Scenario

Michael Frank^{1,†}, Jürgen Student^{2*}, Wolfgang Albrecht^{2*}, Anna Havekost^{2*}

²Uniper Kraftwerke GmbH, Germany

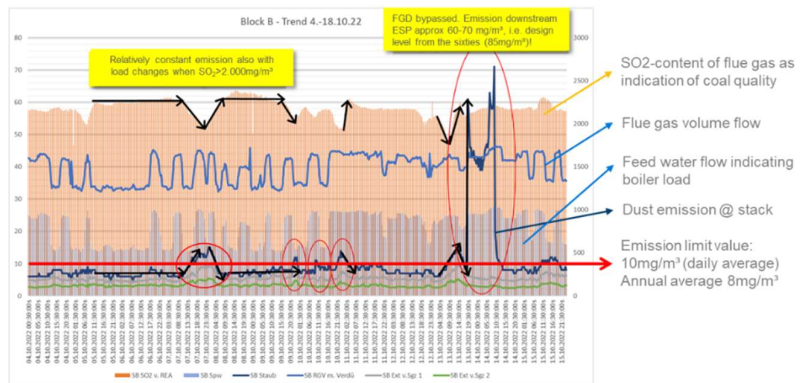
Analysis of a vast amount of data from taken from the plant control system revealed a strong sensitivity towards coal quality and boiler load. In the graph shown in picture 3 it becomes obvious, that as long as the SO₂-content of the flue gas is above 2.000 mg/m³, dust emissions are relatively stable even when load changes are carried out. However, once a different coal quality with less sulfur was fed, emissions at once increased above the daily average limit when load changes were requested at the same time. Since the existing ESP controllers are not able to automatically mitigate back corona, operators must react by switching back to a different coal stock with better coal.

Picture 3 - Process data showing influence of coal quality and FGD-effect

The role of the downstream wet Flue Gas Desulfurization (FGD) system is essential for meeting dust emission limits. When the FGD had to be bypassed due to operational issues, emissions at once went up to 60 – 70 mg/m³ which is approximately the original design level of the ESP-systems alone. Such operation is declared to be an emergency condition and is allowed and limited to occur only a few hours per year.

With this base assumption, the results of the modelling shown in picture 10 mirrors today's actual behavior, i.e. emissions from the combined ESPs of approx. 72 mg/m³ - refer also to picture 3 with FGD in bypass operation. In combination with a FGD dust collection rate of approx. 90%, the resulting stack emission is approx. 7 mg/m³ under favorable and stable conditions.

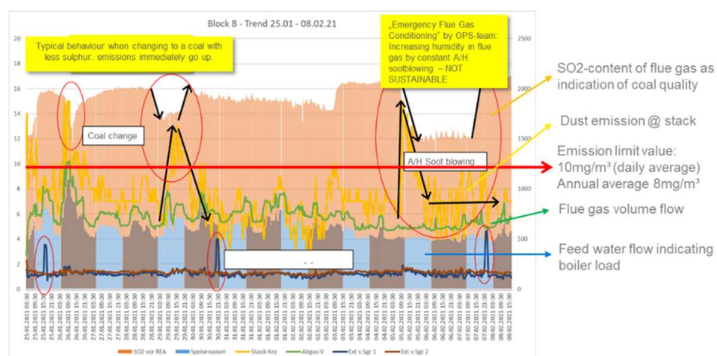
The uphill battle of the OPS-team can be seen on the next graph (picture 4). There are situations, when there is not alternative coal stock yard at hand when they need it. In those cases, their experience has taught them to deploy constant A/H soot blowing to increase humidity and so to improve ESP field strength.

Picture 4 - "Emergency Flue gas Conditioning" by continuous A/H soot blowing

The effect of such “Emergency Flue Gas Conditioning” is quite amazing: Emissions can be brought down for a while until a better fuel is found on the stockyard or load must be reduced if no better is available. However, there are significant consequences for the A/H. Steam soot blowing in a continuous manner damages the heating surfaces which eventually will deteriorate A/H performance, which in turn has a negative effect on ESP performance when flue gas temperatures go up.

Some FGC does work also here, though. In the process data graph 4, the influence of moisture conditioning is clearly visible: when the ops team deploy soot blowers in the air heaters in continuous mode as a last resort for a short period, emissions go down significantly. The rotating air heaters provide excellent mixing and homogenous distribution of the water vapor which brings temperature and volume flow down plus increases flash-over voltage of the flue gas thus enabling higher power input and lower emissions.

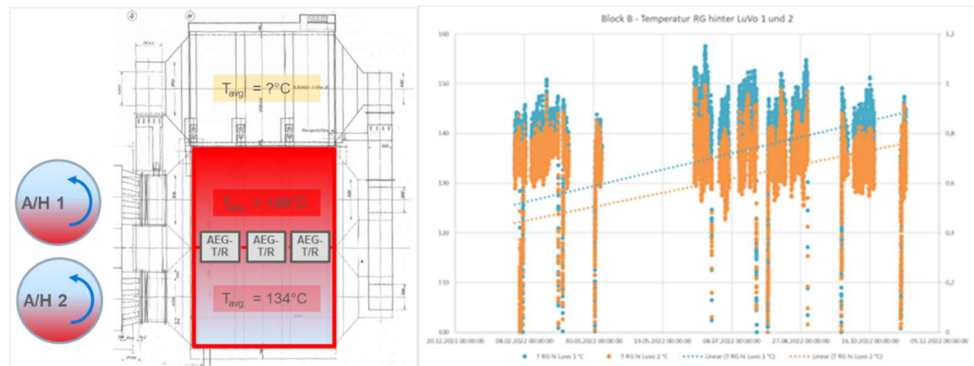
Picture 5 and the corresponding graph show the variations of A/H outlet temperatures, which cause a significant temperature drop perpendicular to gas flow direction, i.e., across one bus section of the ESP.

Picture 5 - Temperature distribution and inlet temperatures to Main ESP

controller for each bus section, controllability of the rather large bus sections is relatively poor. Especially when lower sulfur coals are fired, it can be expected that this skewed temperature profile adds to the challenge by also producing an ash resistivity slope across the bus section.

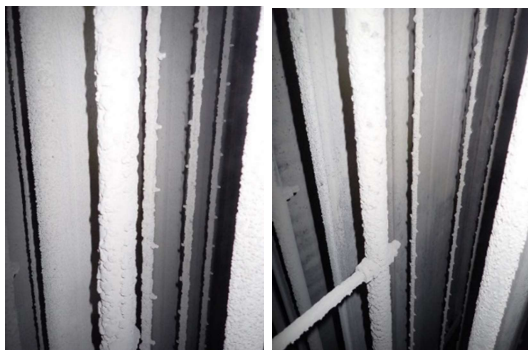
Picture 12 - Ash deposits on collecting and discharge electrodes

When inspecting the ESPs in July this year after an extended period of standstill, both discharge and collecting electrodes were found to be covered with layers of hard and dry fly ash (picture 12). Hoppers were found to be reasonably emptied.

However, the ash deposits were not susceptible to normal rapping operation, i.e., manual cleaning would be needed before the next start up. While manual cleaning using sand blasting or other rather rough methods are quite effective removing ash layers from the electrodes, they also bear the risk of significantly damaging electrodes if not handled with utmost care. Alternative methods using dry ice (solid carbon dioxide) should be investigated.

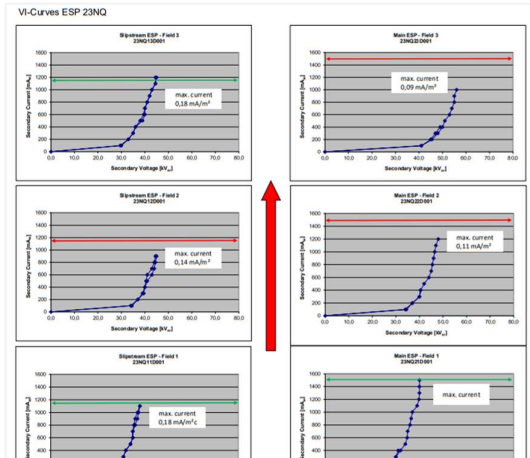
Voltage/current characteristics in picture 13 taken some while before the inspection under presumably similar cold air conditions indicate a very late corona onset which is due to the isolating nature of the ash cake enclosing the discharge wires [1].

Picture 13 - Cold air V/I characteristics before ESP inspection

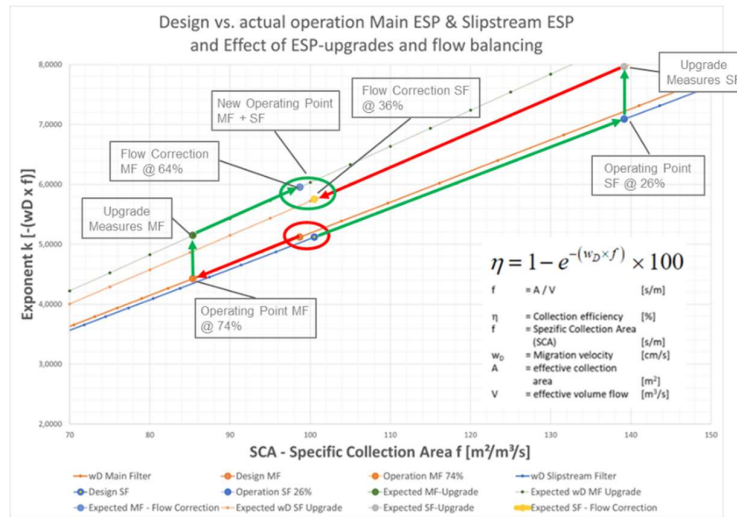
Picture 18 - Design calculations in Deutsch-diagram

From the design calculations shown in picture 17, we can see that the expected improvement of ESP performance with upgrade measures as described in chapter 5 should be sufficient to achieve a margin large enough to cope with fluctuations encountered so far. The graph of the Deutsch-equation in picture 18 shows the effect broken down to each upgrade measure. In total, all measures selected will result in a fairly large margin which should allow the plant to operate safely below the statutory limits.
